## **BUCKLE**

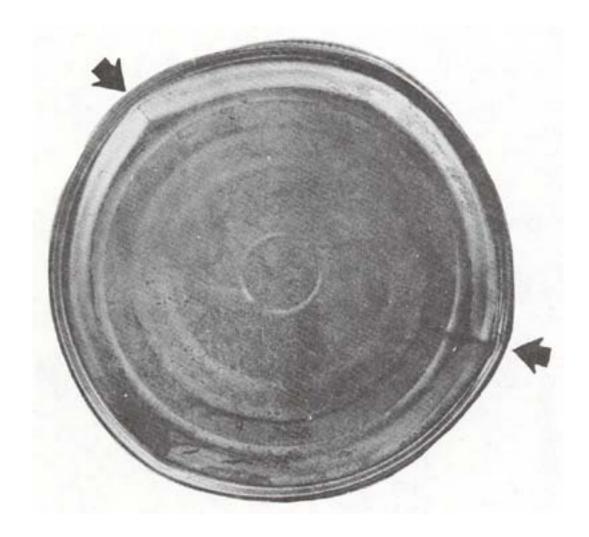
Table IV, Defect No. 111, Major defect. A permanent distortion of a counter sink (channel next to end seam). Cause by excessive internal pressure developed during processing. The distortion of the end seam is readily noticeable at first glance. There is some suspicion that the end seam has been placed under tension sufficient to jeopardize the hermetic seal.
